ENERGY AUDIT REPORT OF

NATIONAL ENGINEERING COLLEGE

Report Prepared By

BEE Certified Energy Auditor (EA-19217)

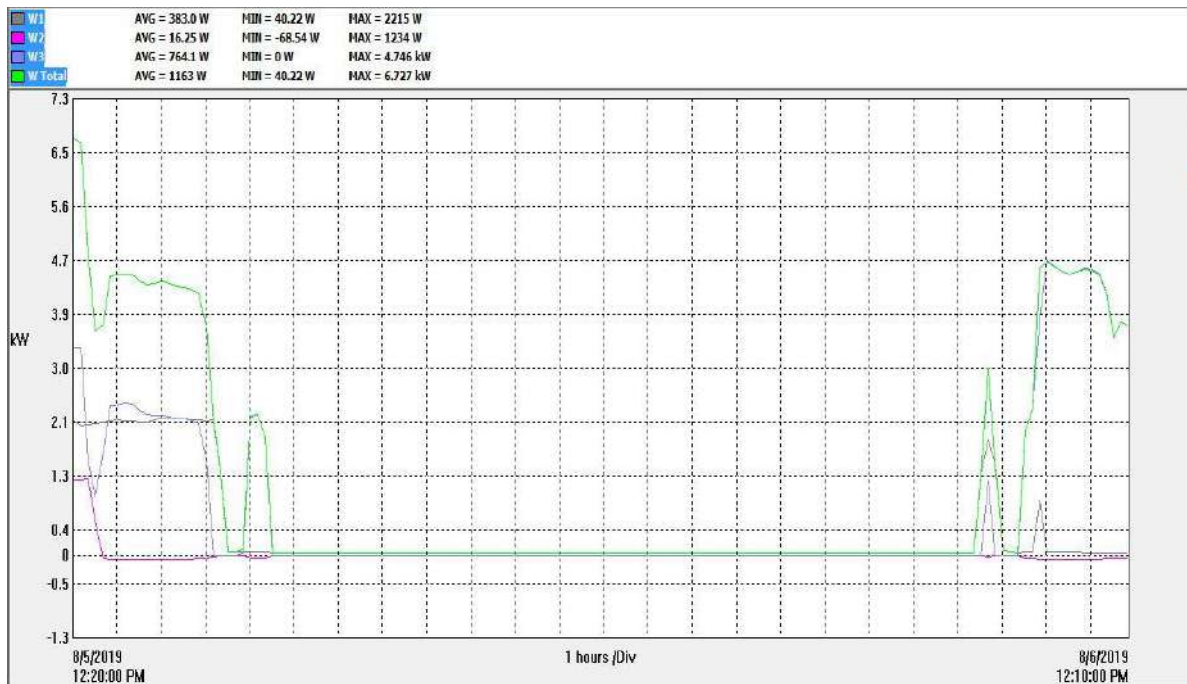
CDIO LAB PANEL

Fig.9 Shows the power (kW) for 24 hours from 5/8/2019 12.20PM to 6/8/2019 12.10PM
 Inference: power distribution is not balanced. Phase 2 is found to be unbalanced and it loaded only 2% of the total.

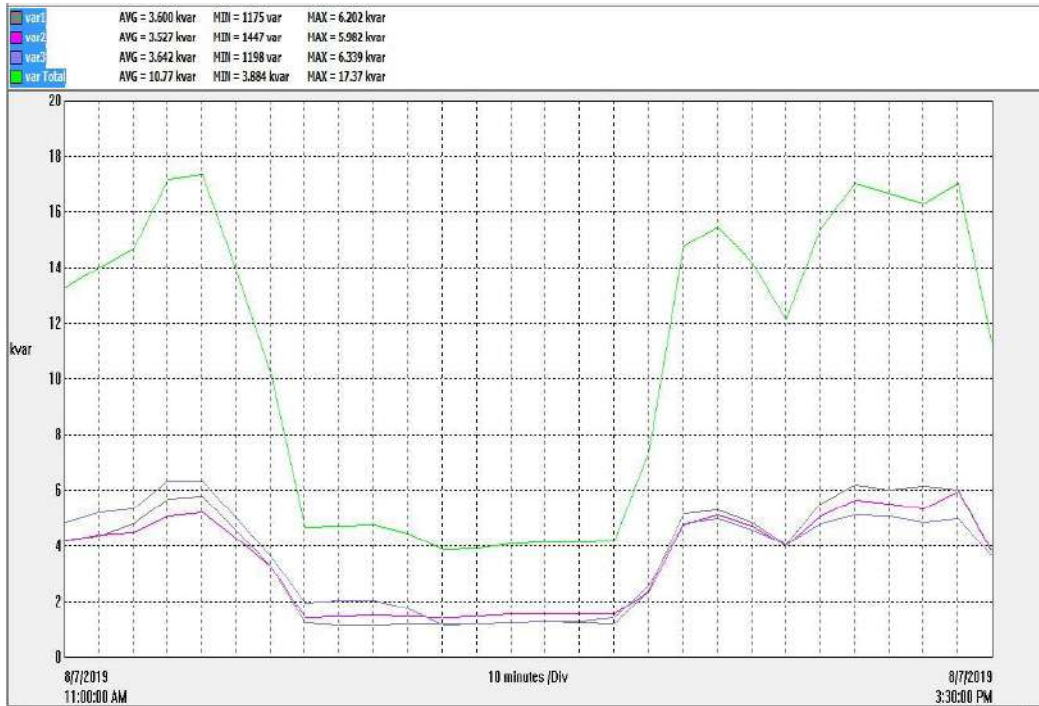
Fig.29 Shows the reactive power (kVAR) for 4.30 hours from 7/8/2019 11.00AM to 7/8/2019 3.30PM
Inference: KVAR shows normal condition.

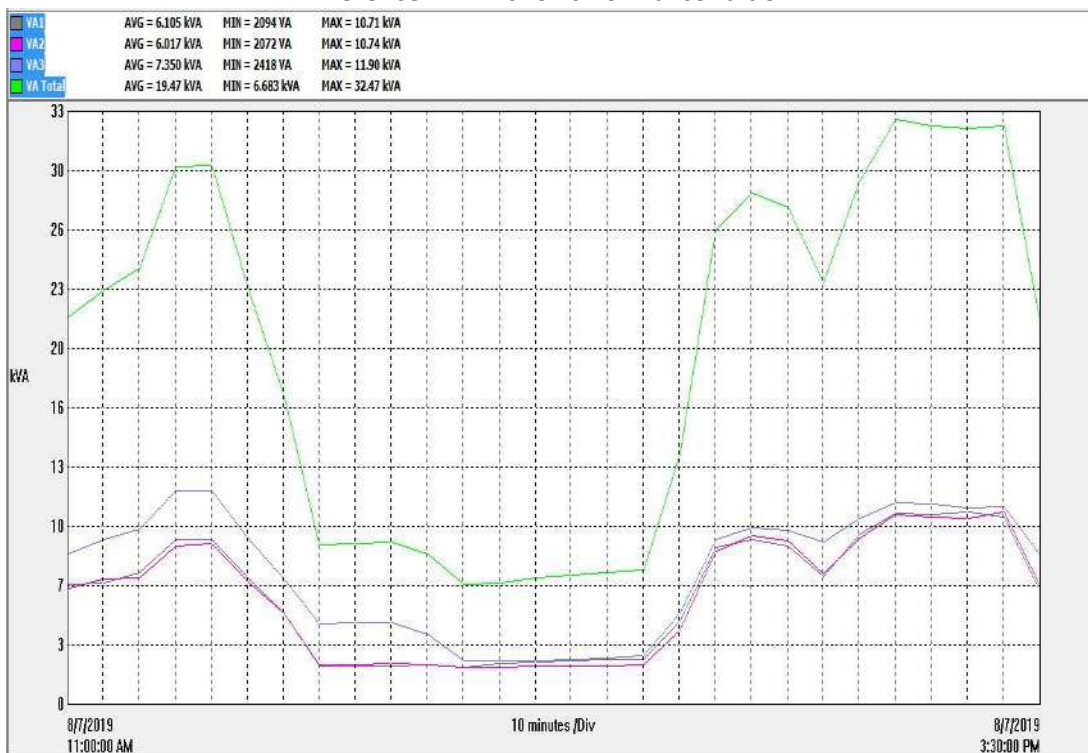
Fig.30 Shows the power (kVA) for 4.30 hours from 7/8/2019 11.00AM to 7/8/2019 3.30PM
Inference: No specific abnormality found here.

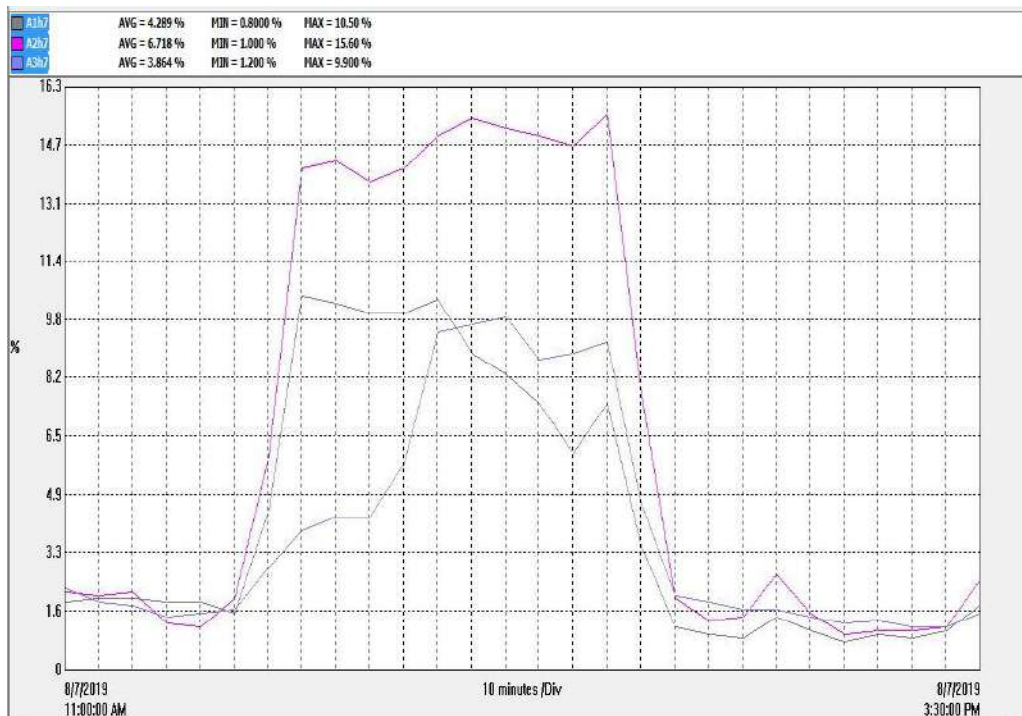
Fig.32 Shows the 7th order THD (voltage harmonics) for 4.30 hours from 7/8/2019 11.00AM to 7/8/2019 3.30PM
Inference: Harmonics seems to be normal. No need of harmonic filters.

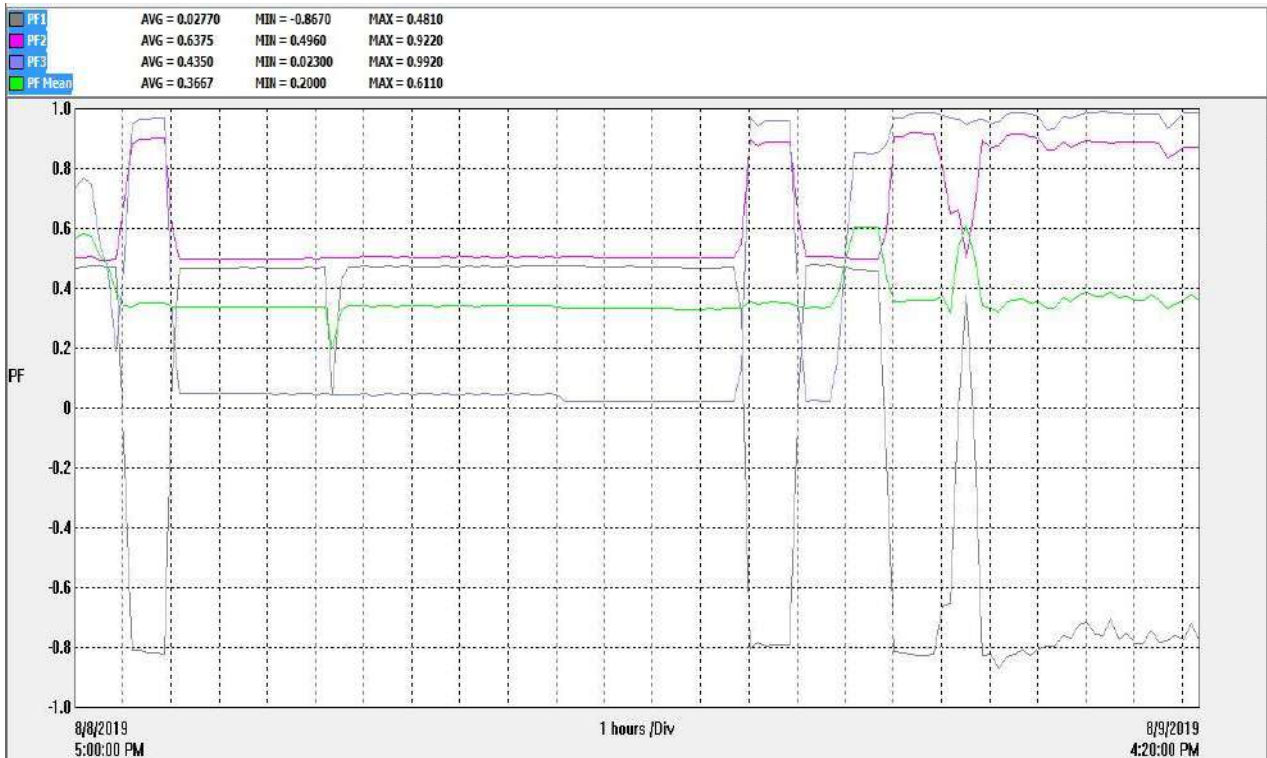
Fig.45 Shows the power factor (PF) for 24 hours from 8/8/2019 5.00PM to 9/8/2019 4.20PM
 Inference: Unbalanced found here. Need to be improve the PF.

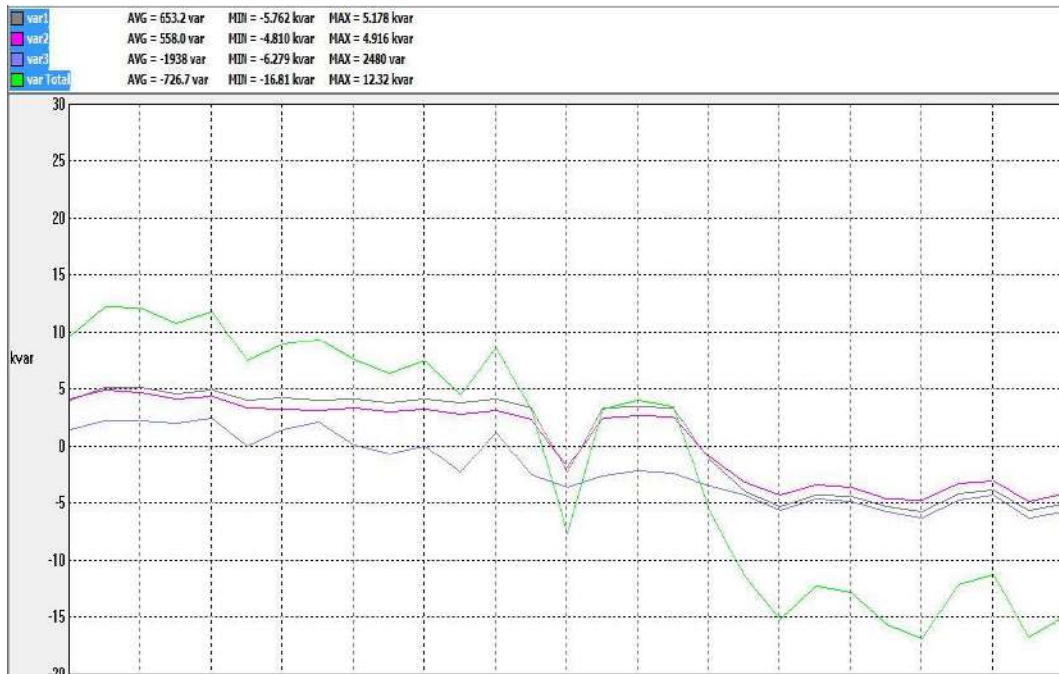
Fig.62 Shows the reactive power (kVAR) for 4 hours from 8/8/2019 5.00PM to 9/8/2019 4.20PM
 Inference: Phase 3 shows very low KVAR compare to other two phases. Need to be check.

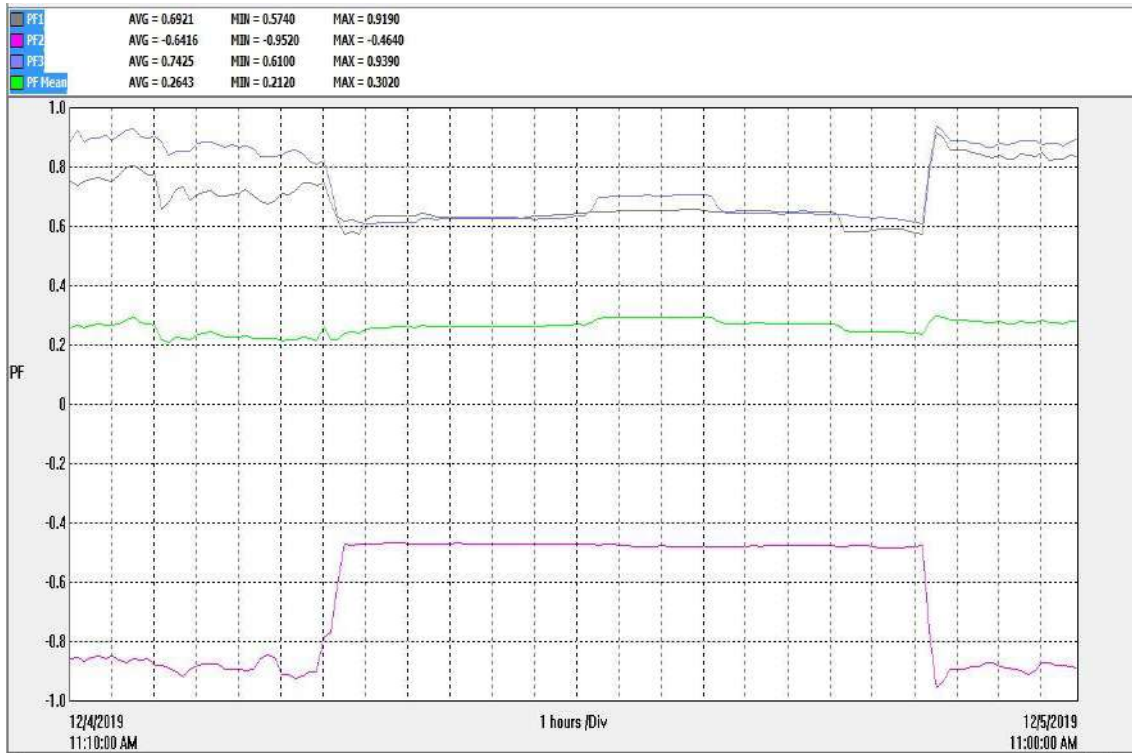
Fig.69 Shows the power factor (PF) for 24 hours from 4/12/2019 11.00AM to 5/12/2019 11.00PM
Inference: unbalance found in Phase 2. Need to improve PF.

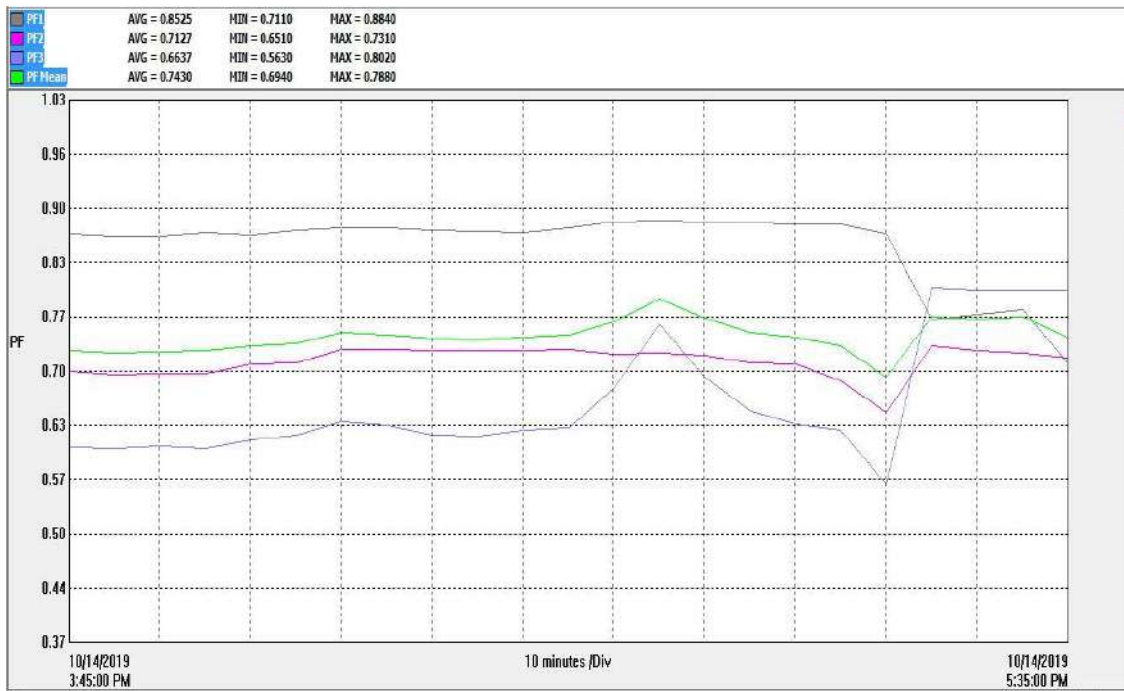
Fig.85 Shows the power factor (PF) for 2.0 hours from 14/10/2019 3.45PM to 14/10/2019 5.35PM
 Inference: No unbalanced found here. Need to be improve the PF.

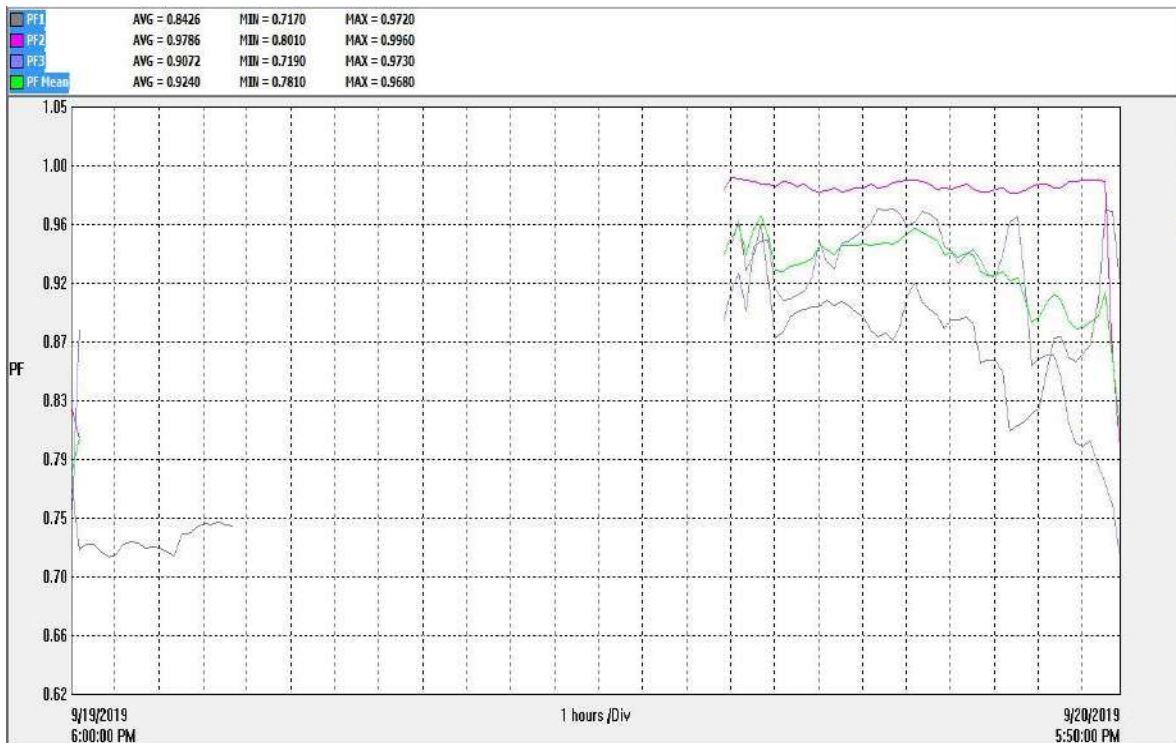
Fig.109 Shows the power factor (PF) for 24 hours from 19/9/2019 6.00PM to 20/9/2019 5.50PM
Inference: No unbalanced found here. Need to improve the PF.

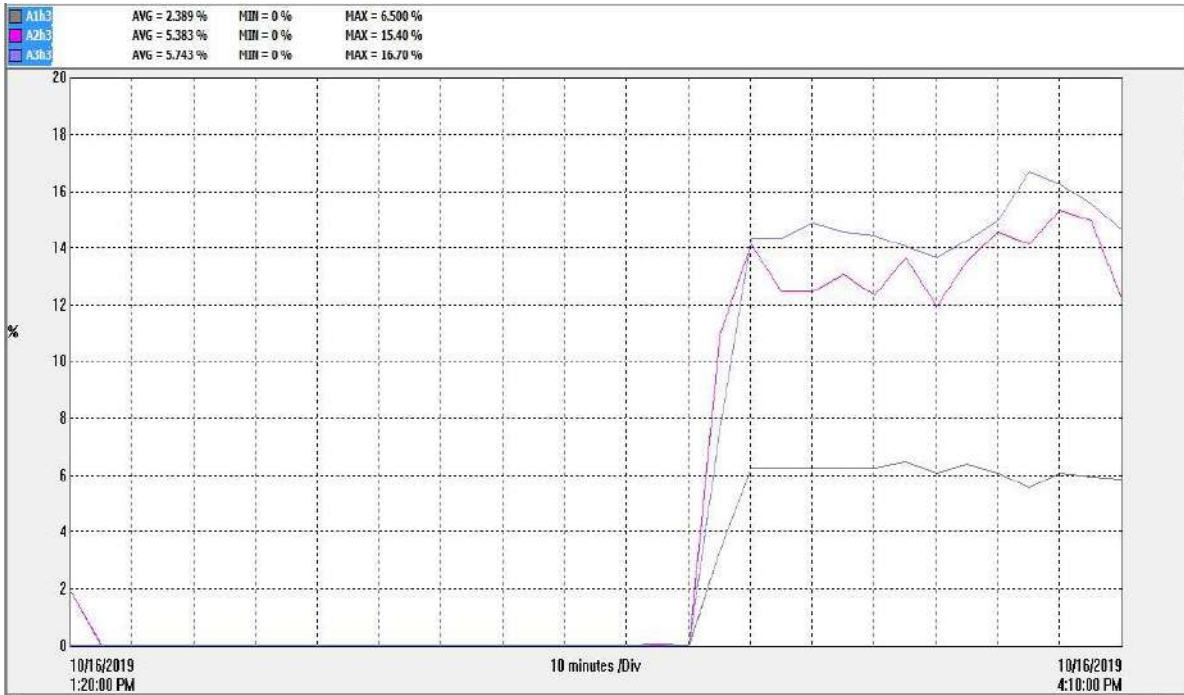
Fig.147 Shows the 3th order THD (voltage harmonics) for 3.10 hours from 16/10/8/2019 12.00PM to 16/10/2019 4.10PM

Inference: Harmonics seems to be normal. No need of harmonic filters.

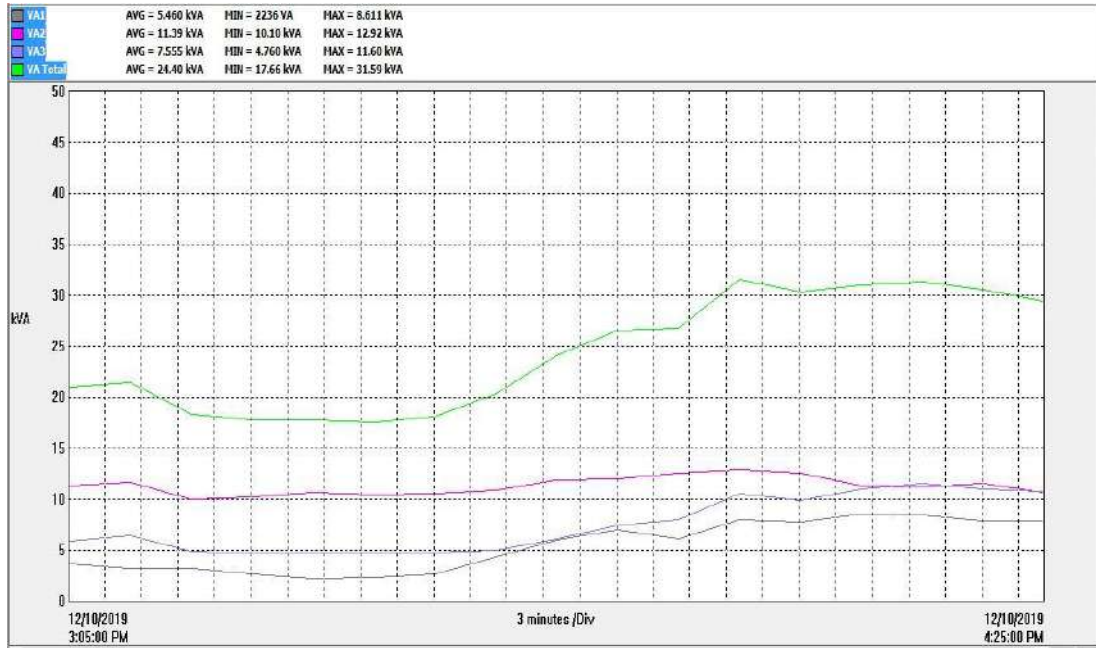
Fig 183. Shows the power (kVA) for 20MINUTES from 10/12/2019 12.55PM to 10/12/2019 4.25PM
Inference: Phase 1 shows very low KVA.
